STEREOMICROSCOPE INSPECTION OF POLISHED ALUMINUM COLLECTOR 50684.0. M. C. Rodriguez¹, M. J. Calaway², J. H. Allton³; ¹ Geocontrol Systems- ESCG at NASA/Johnson Space Center, Houston, TX 77058; melissa.rodriguez-1@nasa.gov, ² Jacobs- ESCG at NASA/Johnson Space Center, Houston, TX 77058, ³ NASA/Johnson Space Center, Houston, TX 77058.

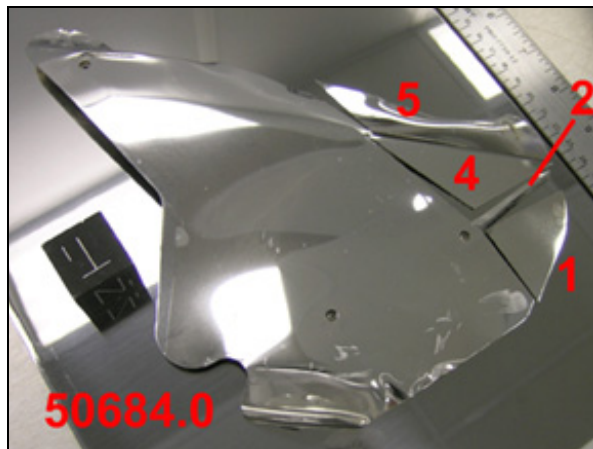
Fig. 1. Polished aluminum collector after subdivision in 2005. Portions 1, 2, 4, and 5 were previously imaged. Imaging of portion 50684.0 is in progress.

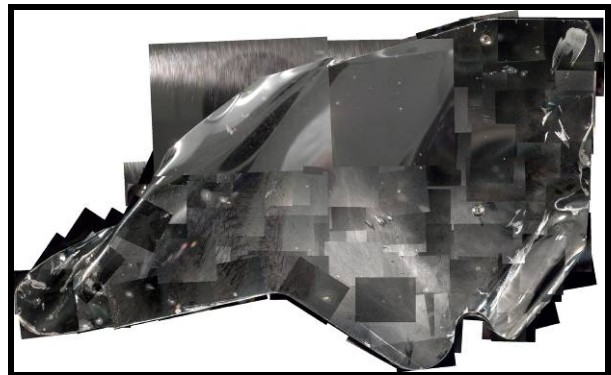
Fig. 2. Overview image of remaining polished aluminum kidney, 50684.0.

Stereomicroscope Observations: Post-flight characterization shows that the collector area has remained intact and did not fracture during impact. However, the Al collector was distorted and bent from the original dimensions. Mud and salt evaporite contamination from the Utah lakebed landing site is observed on the outer edges of the collector (Fig. 3) in smears and dried droplet formations. An extremely fine layer of particulate contamination is also present on the interior, flatter portions of the collector, recording evidence of physical movements of fragments during the hard landing (Fig. 4). Examples of hypervelocity impact craters, found on the right-hand portion of the image, are shown at higher magnifications in Fig. 5. All of the crater shapes appear to be uniformly round diameters at the collector surface and have unevenly splayed protruding edges. The interior “pit” bases also appear to be consistently rounded. Various gouges and scrapes from the hard landing have also been imaged; these are markedly different from impact cratering features and also appear near collector edges (Fig. 6).

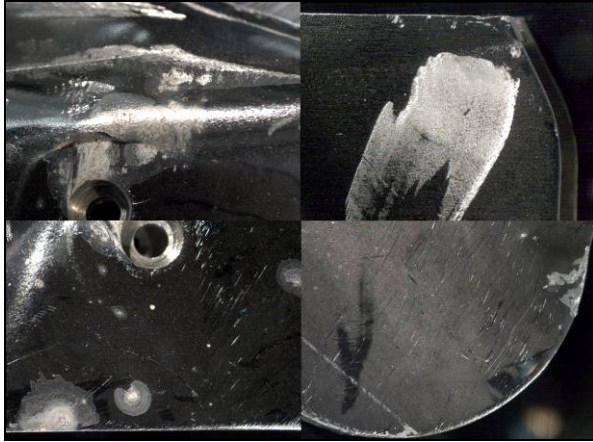
Fig. 3. Four examples of Utahogenic contamination near collector edges at 0.63X.

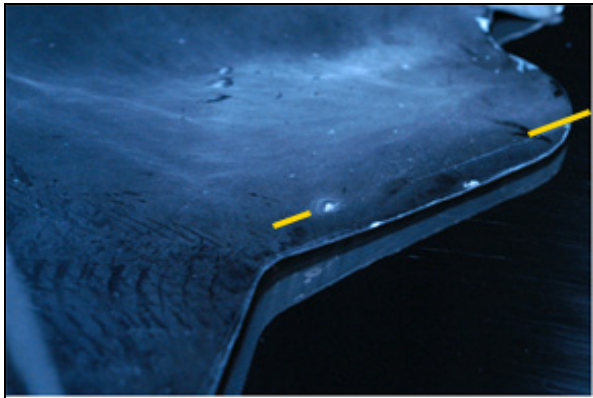
Fig. 4. Patterns in extremely fine material coating the polished surface shows evidence of physical movement of fragments during hard landing.

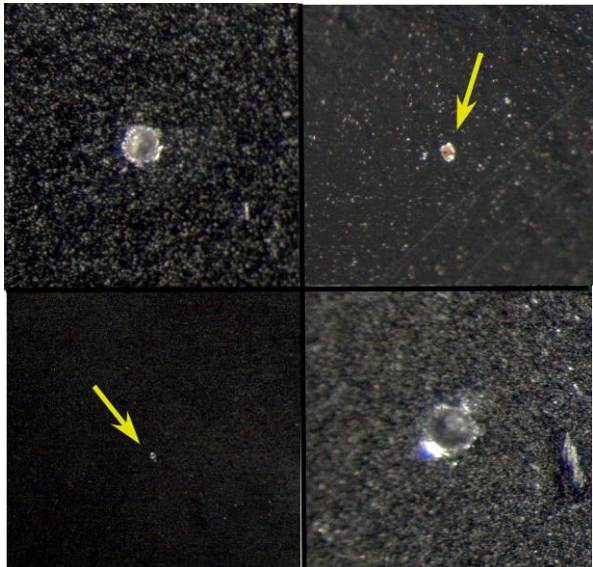
Fig. 5. Examples of microcraters on polished aluminum surface. Image on lower left has not been positively identified.

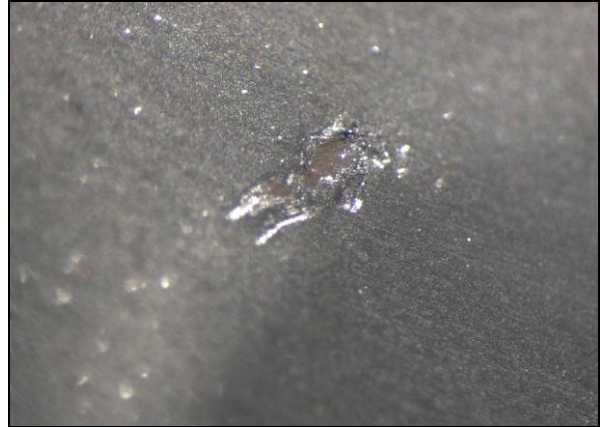
Fig. 6. Irregularly shaped gouge on aluminum kidney surface.
